# Manhole Inspection Summary

Manhole # S49EE\_015MH

Insp Date: **7/15/08 9:34 AM**

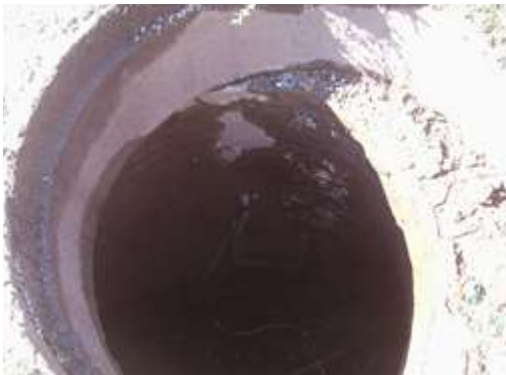
Defect 1

infiltration

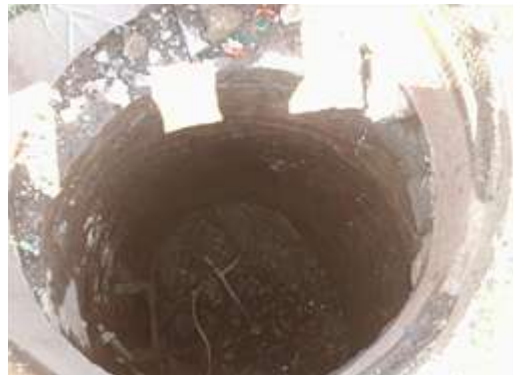
Defect 2

frame leaks

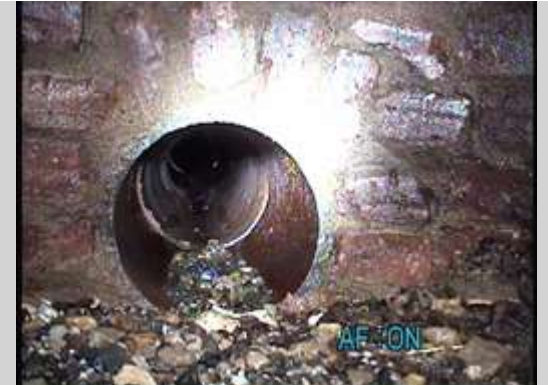
12 O'Clock Outflow

8 in. Circular Gravity Sewer  
Pipe Out @ 12 O'Clock

Infiltration: **None** Pipe Seal Cond: **Sound**
